# Concrete Spalling

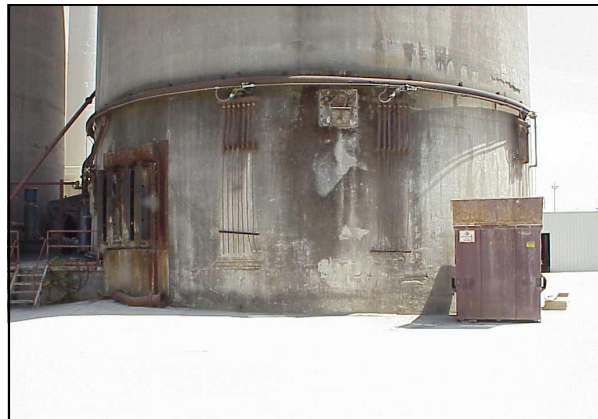
Glacier Northwest Silo 14  
Spalling Concrete at Base Prior to Removal of  
Loose Concrete

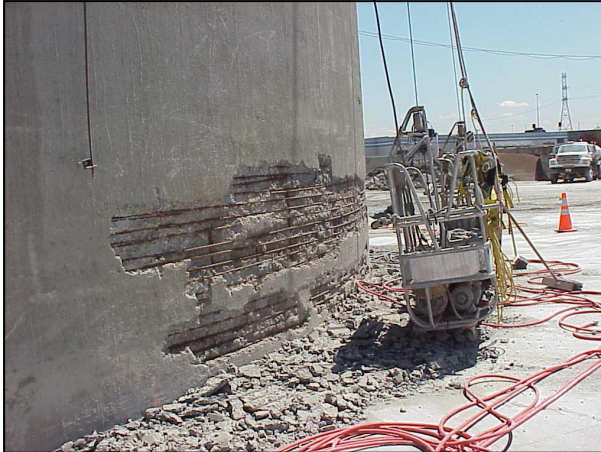
Glacier Northwest Silo 14  
Spalling Concrete at Base After Removal of  
Loose Concrete

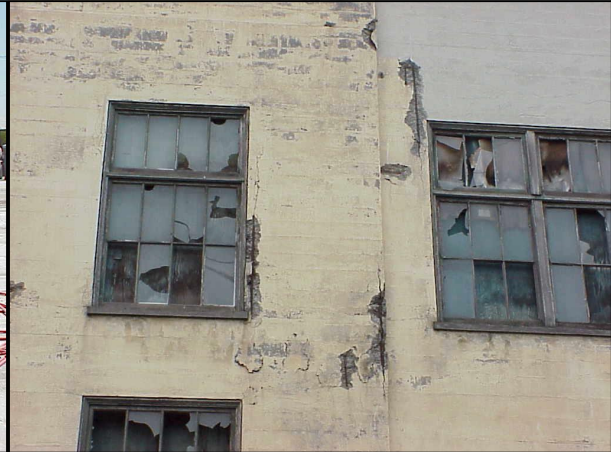
Pacific Coast Feather  
Typical Concrete Spalling at Window Jambs,  
Field and Corners

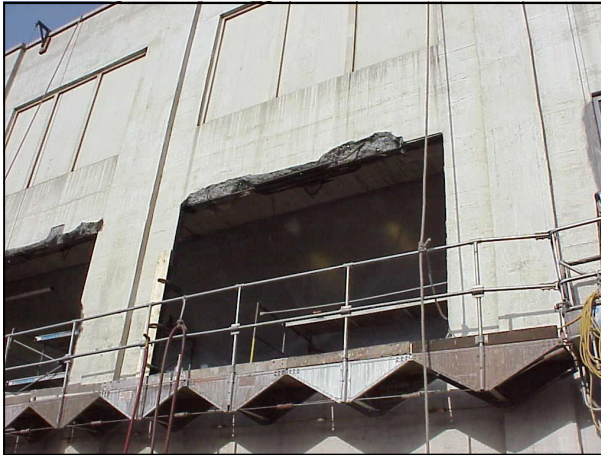
Spalling Concrete at Window Headers  
Poorly Consolidated Concrete

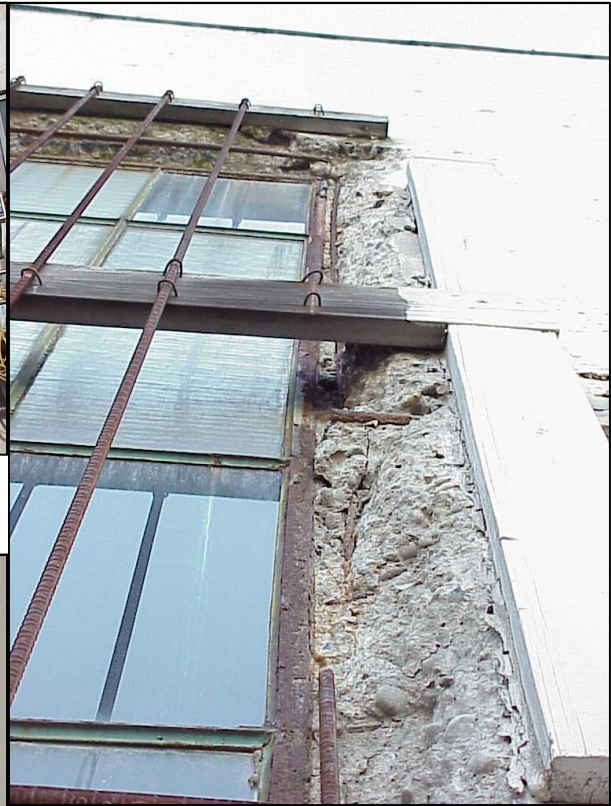
Spalling Concrete at Window Headers  
Poorly Consolidated Concrete

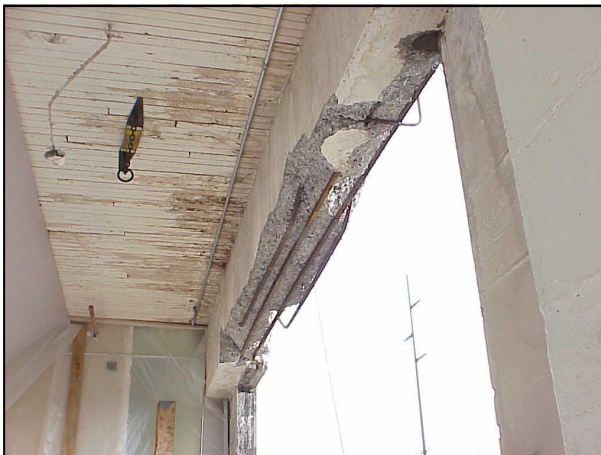
Frye Industrial Buildings  
Spalling Concrete at Window Jambs and Heads.  
This Damage Was Caused by a Combination of  
Rebar Too Close to the Edge of the Jamb and  
Corrosion of the Embedded Steel Window  
Frames.
