## Water and Masonry Decay

Bob Mitchell, Estimator  
Pioneer Masonry Restoration Company, Inc.  
PO Box 70110 , Seattle, WA 98127

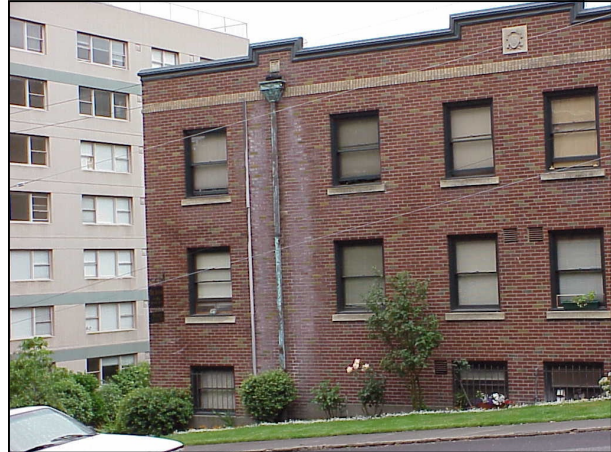
Water damage from leaking scupper (above)

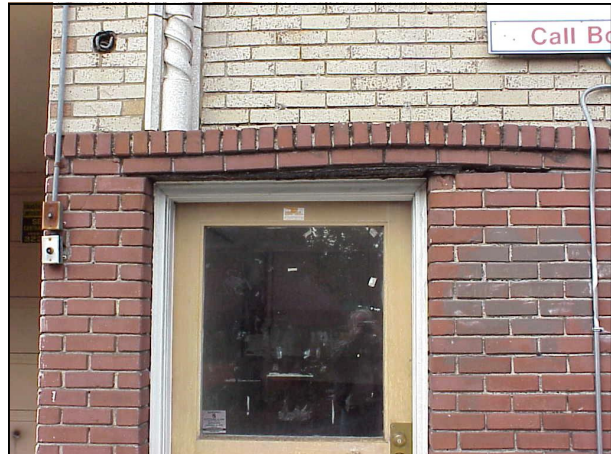
Oxide Jacking at steel lintel

We call this movement of the masonry by the structural elements "Oxide Jacking." Once Oxide Jacking has begun, the only way to stop it is to remove the masonry and protect or replace the iron or steel element or keep the metal totally dry. Obviously, keeping the metal totally dry is not an option in the real world!

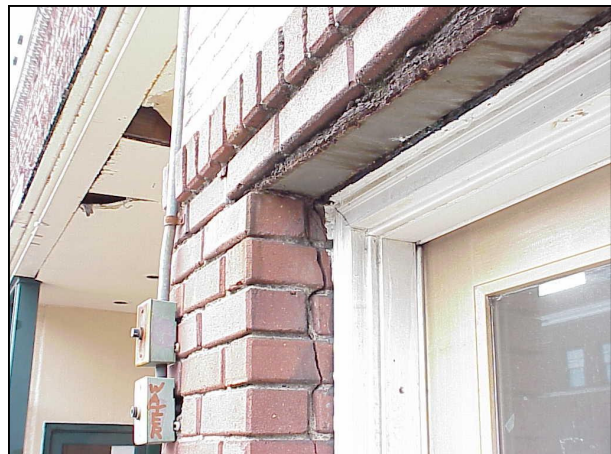
Restrained side of embedded steel lintel splits brick door jamb. Note: brick are road pavers.

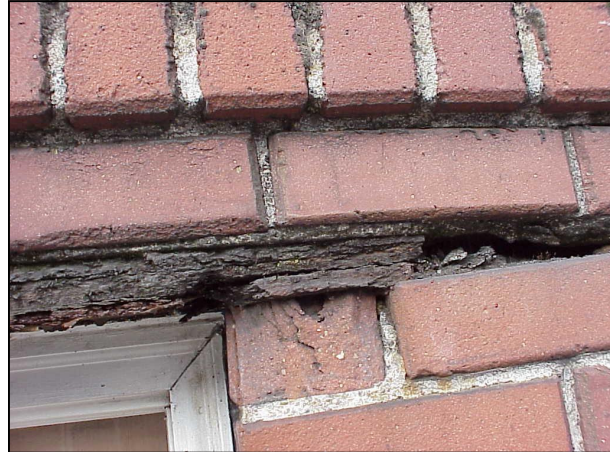
Oxide growth at unrestrained side of steel lintel is much greater than loaded side

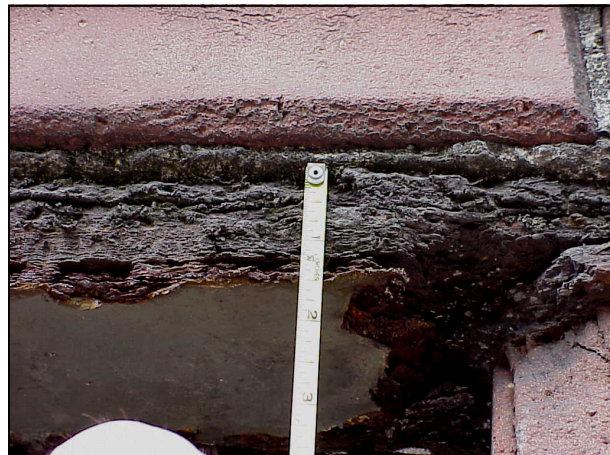
Original 1/4inch thick lintel is now 1-1/2 inches high and has lost most of its structural integrity

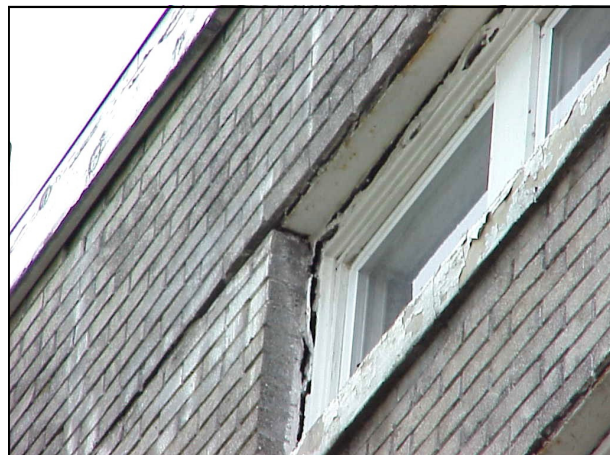
Classic example of brick veneer being moved around by Oxide Jacking at steel lintels
